## Evaluation of Restoration Alternatives for the Northwest Fork of the Loxahatchee River

**South Florida Water Management District  
Watershed Management Department  
Coastal Ecosystems Division  
March 21, 2005**

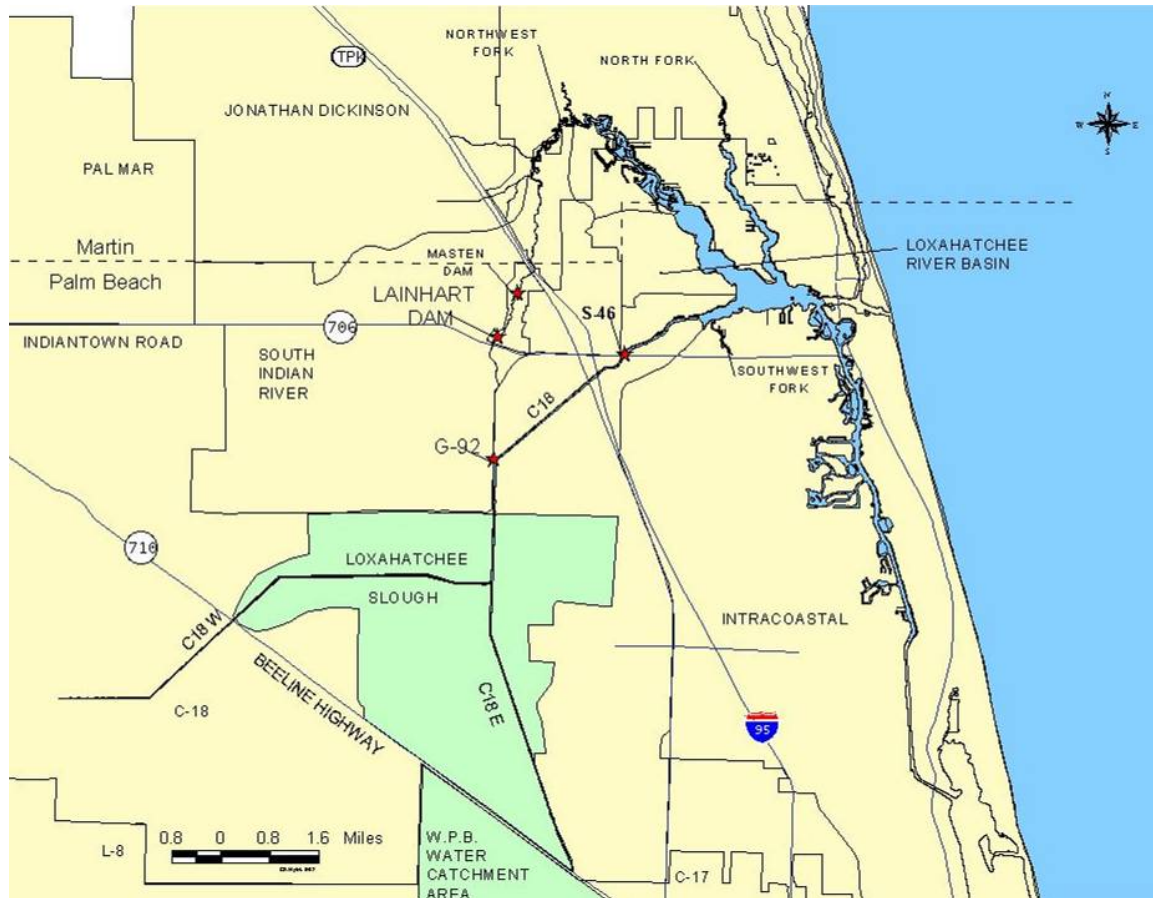
**Figure 2-1.** Location of the Loxahatchee River, Major Tributaries, Natural Areas, and Water Control Structures in the Watershed.

The current headwaters of the Wild and Scenic portion of the Northwest Fork of the Loxahatchee River begin in the Hungryland Slough and Loxahatchee Slough. From the Loxahatchee Slough, water flows north in the C-18 canal, through the G-92 structure, over the Lainhart Dam into the natural river stream of the Northwest Fork. It enters Martin County north of Indiantown Road, (S.R. 706), then enters JDSP and continues along a northerly course, and then bends east and continues southeast through to the embayment of the Loxahatchee River. Although the majority of the water that feeds the Northwest Fork comes from northern Palm Beach County, water also flows to the Northwest Fork from southern Martin County, through Cypress Creek, Hobe Grove Ditch, Wilson Creek, Moonshine Creek and Kitching Creek. The North Fork headwaters are defined by the Atlantic Coastal Ridge in eastern Martin County and flow south-southeast into the embayment. In 1957 the Southwest Fork was channelized to form the C-18 canal to move water flows to the northeast, providing flood control to northern Palm Beach County. The Loxahatchee Estuary's embayment is located at the center of three major tributaries- the Northwest Fork, the North Fork and the Southwest Fork (**Figure 2-1**).

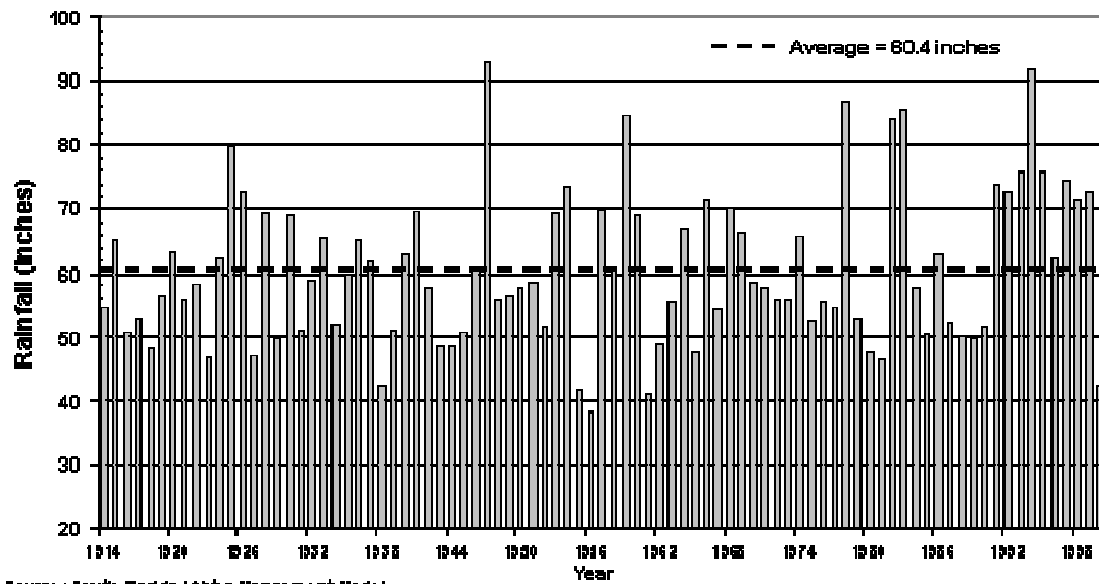
**Figure 2-3.** Long-Term Annual Rainfall for Northern Palm Beach and Southern Martin Counties (1914–2000) Based on the SFWMM.

Annual rainfall amounts received within northern Palm Beach and southern Martin Counties are summarized in **Figure 2-3** and represent the years from 1914-2000 (data from South Florida Water Management Model, version 9.7). Mean annual rainfall for the entire 86-year period of record was 60.4 inches with a median of 57.7 inches. The maximum annual rainfalls recorded were 92.9 inches in 1947 and 91.6 inches in 1994. Minimum rainfall values occurred in 1956 (38.4 inches) and 1961 (41 inches). Review of the distribution of annual rainfall data over time showed that a variance of about 10 percent of the mean ( $\pm 6$  inches) occurs about once every 3 years on average. Extreme dry and wet periods can be defined as a variance of more than 20 percent of the mean ( $\pm 12$  inches). Based on this definition, the long-term record shows that an extreme dry period occurs within the basin once every 8.6 years, while extreme wet periods occur about once every 5.7 years.

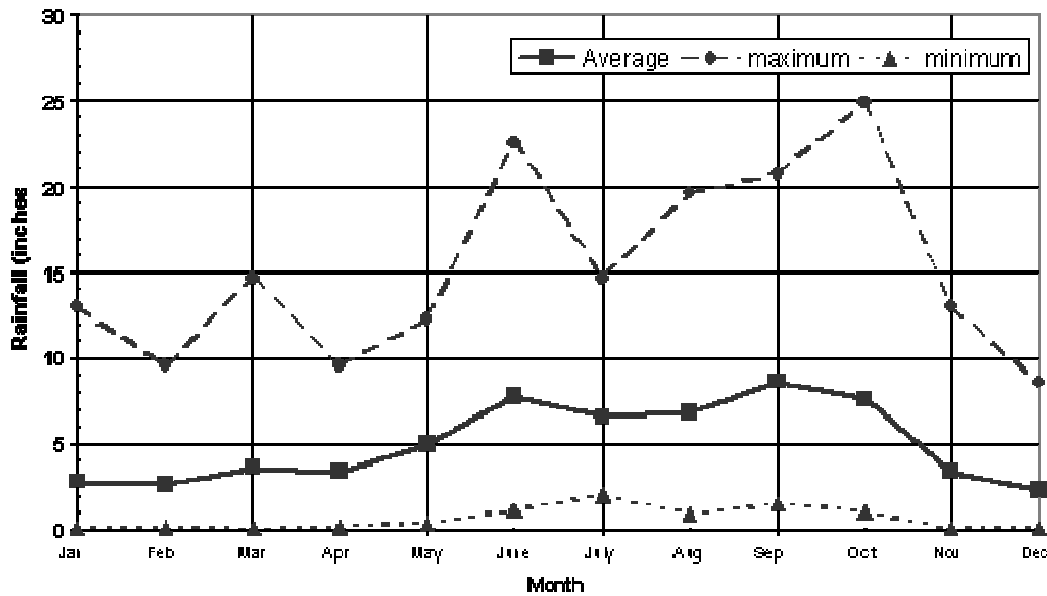
Source: Model results from the South Florida Water Management Model (SFWMM)

The average, minimum, and maximum monthly rainfall amounts for northern Palm Beach and southern Martin Counties for 1914-2000 are summarized in **Figure 2-4**. On average, the highest rainfall of 8.7 inches per month occurs during September, while minimum average values range from 2.3 – 2.8 inches per month for December, January and February. May and November are transitional months and sometimes represent key months for prolonging or reducing a drought or flood condition. Dent (1977a) reported that since the early 1960s, about two-thirds of this precipitation (40.63 inches) occurs during the wet season (June–November), while the remaining one-third (20.42 inches) falls during the dry season (December–May). During the winter and early spring, some years have long periods of little or no rainfall, resulting in a regional drought condition. In contrast, tropical storms or hurricanes over the area can produce as much as 6 to 10 inches of rainfall in one day in the wet season.

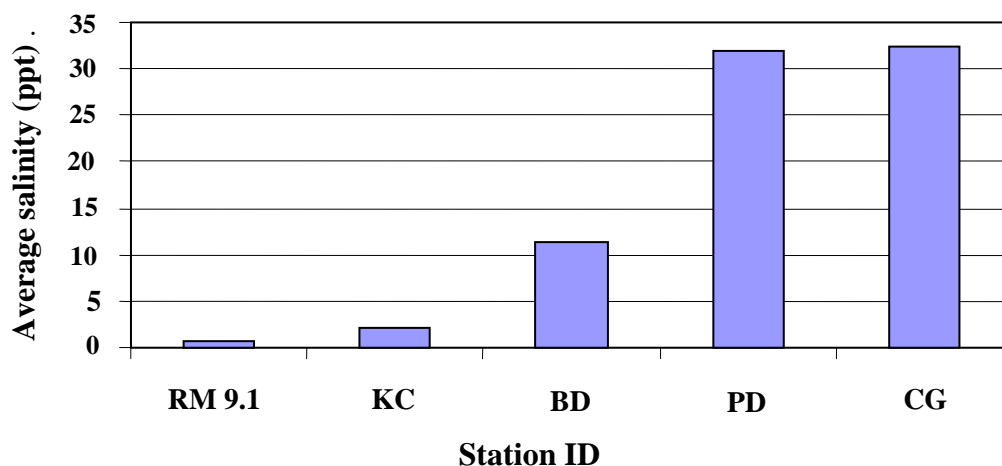
**Figure 2-5.** Average Annual Salinity Gradient in the Loxahatchee Estuary.

Salinity distribution in the Loxahatchee Estuary is characterized by longitudinal and vertical salinity gradients that change daily with tides and seasonally with the quantity of the freshwater inflow. A network of tidal and salinity monitoring stations has been deployed in the estuary since October 2002. **Figure 2-5** shows the annual average salinity over the period from November 1, 2003 to October 31, 2004.

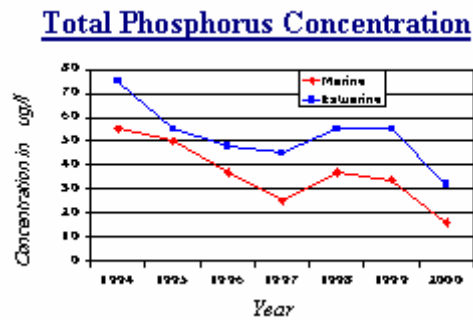
**Figure 2-7.** 1994-2000 Total Phosphorus Concentrations (Dent, 2001).

The annual average total phosphorus (TP) concentrations for the period 1994–2000 for seven estuarine stations ranged between 31 to 75 ppb (see **Figure 2-7**). This range of values is considered high. These concentrations were similar to concentrations observed prior to 1990. These surface water concentrations were much lower than the statewide average of 80 ppb for the 1990 to 1998 period. (Dent, 2001)

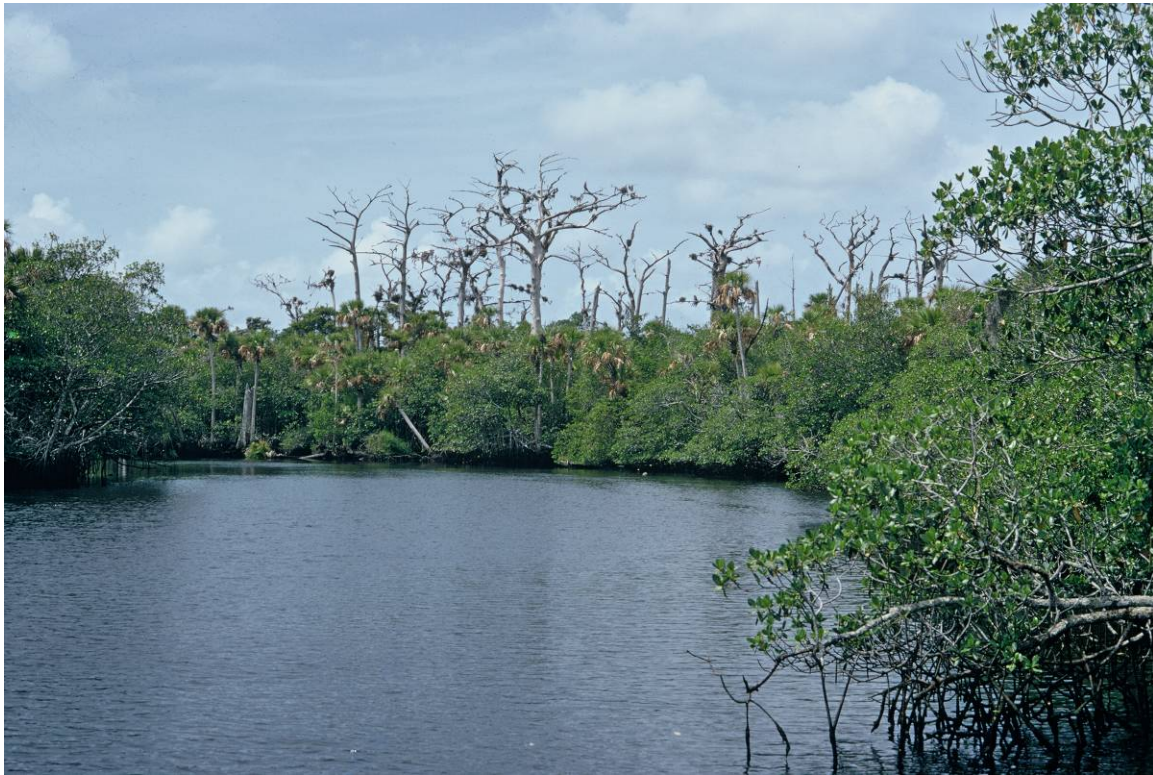
**Figure 3-1.** Photograph of the Northwest Fork of the Loxahatchee River taken in 1971 by T. Alexander.

Alexander and Crook (1975) utilized aerial photographs and groundtruthing to examine plant communities along the Northwest Fork of the Loxahatchee River and Kitching Creek (**Figure 3-1**). Upon identifying the signature of the most abundant community types, they were able to use photo interpretation to identify the major vegetative communities from a 1940 aerial photograph. Areas of dead and living cypress canopy within a mangrove understory were then field verified in 1970. They concluded that since 1940, areas of wet prairie and swamp hardwoods had been converted to pinelands and mangrove communities because of the lowered groundwater table and the saltwater encroachment between RM 6.0 and RM 8.0. They were able to identify areas of past logging in the aerial photographs, which could explain the loss of mature trees within portions of the watershed. Also, they mentioned the impact of fire, hurricanes and heavy frost on the major plant communities. At RM 6.5, they collected freshwater peat at a depth of 24 inches below the surface. Based on this information, they further concluded that there was no evidence that cypress forest had extended much further downstream than about RM 6. Finally, Alexander and Crook (1975) predicted that the mangrove invasion would accelerate, if anthropogenic activities in the upper floodplain of the river further reduced the freshwater head.

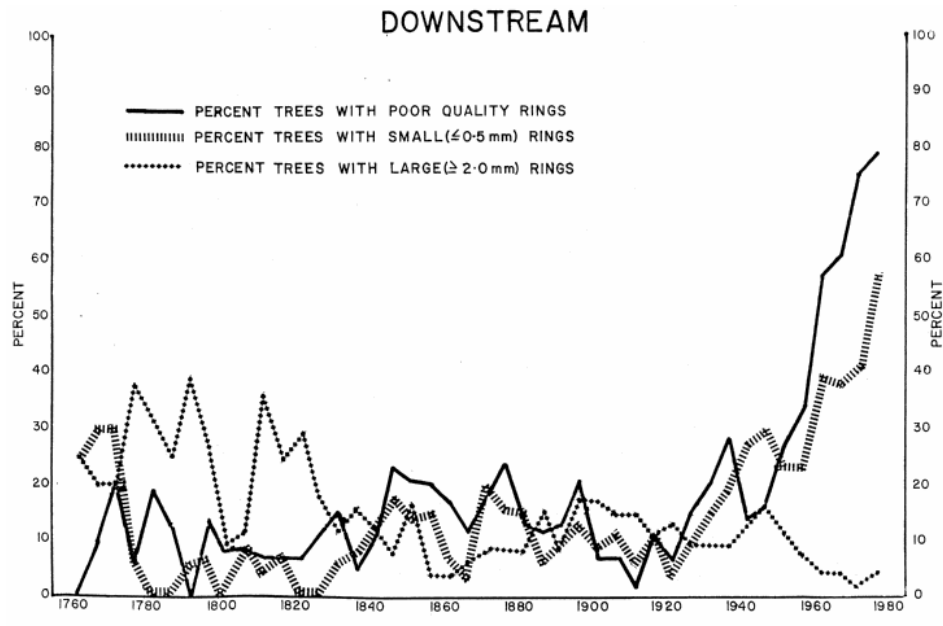
**Figure 3-2.** Changes in Cypress Tree Ring Size and Quality Through Time Downstream of RM 9.0, Northwest Fork of the Loxahatchee River (from Duever, unpublished USGS data).

Between 1979 and 1982, Duever (personal communication) documented the extent of environmental stress in the bald cypress community along the Northwest Fork of the Loxahatchee River. The study examined core samples collected from cypress trees at 21 sites (69 trees in total) located up and down the river to identify changes in tree rings over time. The results of the study indicated that although all of the trees sampled had experienced stress at periodic intervals during their life histories, the proportion of stressed trees downstream of RM 9.0 increased from 30 percent in 1940 to 80 percent in 1982 (**Figure 3-2**). The proportion of stressed trees upstream from RM 9.0 decreased from 11 percent to 3 percent during the same 40-year period (**Figure 3-3**). The study also found a high correlation between the incidence of growth stress and high salinity in surface water and soils.

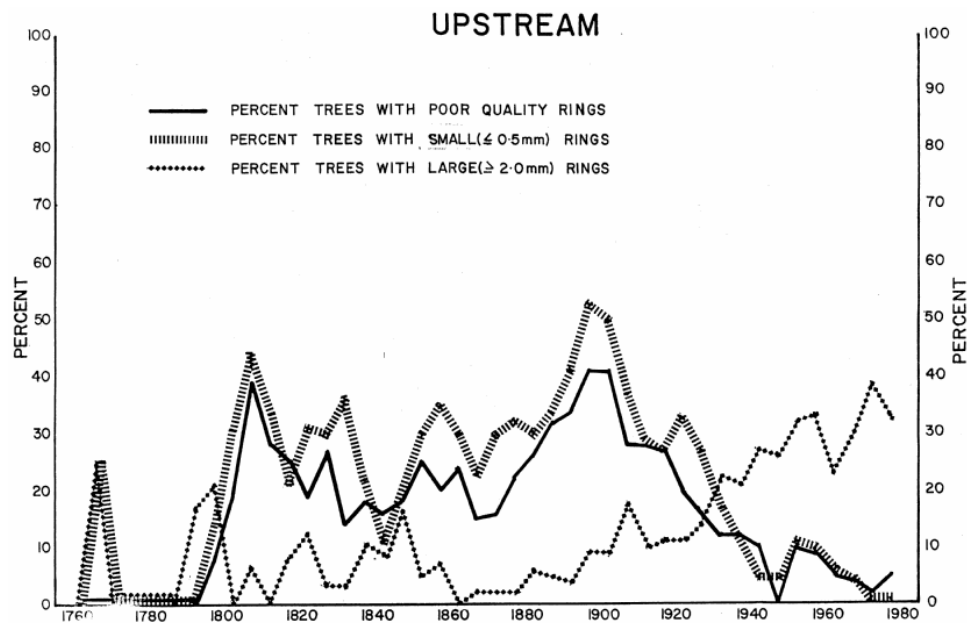
**Figure 3-3.** Changes in Cypress Tree Ring Size and Quality Through Time Upstream of RM 9.0, Northwest Fork of the Loxahatchee River (from Duever, unpublished USGS data)

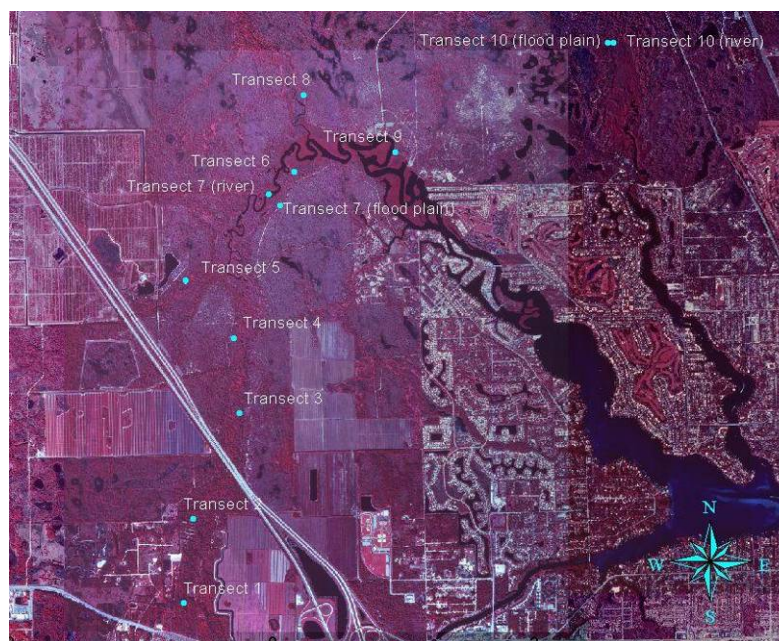
**Figure 3-4.** Location of the 10 Vegetation Transects of the Northwest Fork of the Loxahatchee River. Transects 1 – 6 are D. Worth transects (1983-1984); Transects 7 - 10 are additional Ward and Robert (1996) transects.

Between October 1993 and January 1994, Ward and Roberts (1996) re-examined Worth's six vegetative transects between Indiantown Road (S.R. 706) and the mouth of Kitching Creek. Each 10m wide belt transect was partitioned into 10m<sup>2</sup> plots. A total of 79 plots were surveyed during the study. Generally the density (stems/hectare) of bald cypress (*Taxodium distichum*) increased upstream from Transect #6 (RM 8.4) near Kitching Creek to Transect #1 (RM 14.5) just north of S.R. 706. A noticeable decrease in cypress density occurred at Transect #3 (RM 12.1), which was heavily populated with pop ash (*Fraxinus caroliniana*), red maple (*Acer rubrum*) and cabbage palms (*Sabal palmetto*). These six transects (**Figure 3-4**) were re-examined in the 2003 vegetative study and four new transects were added. Comparisons of the 1993-1994 and 2003 vegetation studies are being prepared for a report summarizing the 2003 vegetation survey.

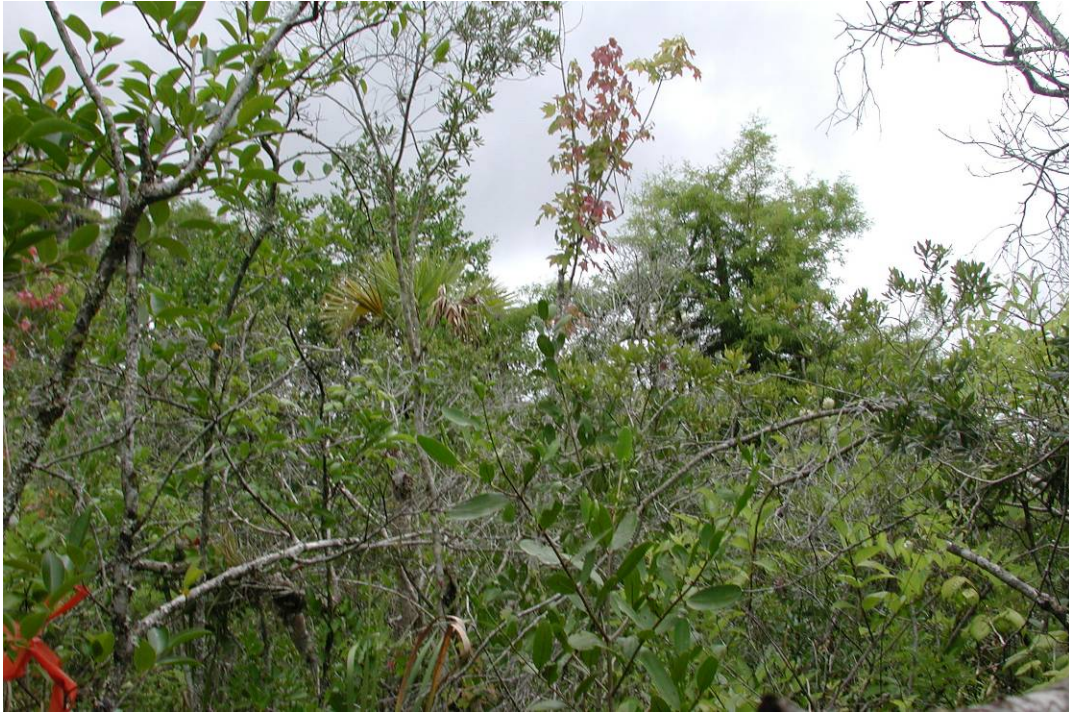
**Figure 3-8.** Example of Forest Type Rmix (Pond Apple, Bald Cypress, Red Maple, Wax Myrtle, Cabbage Palm in a Selectively Logged Area).

Riverine swamps are characterized with the lowest elevations and wettest areas with either inundation or saturation most of the year. Soils are generally sandy with some loam and clay. On the Northwest Fork of the Loxahatchee River, older riverine swamps are dominated primarily by bald cypress (*Taxodium distichum*) communities (Rsw1; **Figure 3-9**), while younger subcanopy swamp communities and impacted areas (i.e. logged) are dominated by pop ash (*Fraxinus caroliniana*, Rsw2). Occasional bald cypress/cabbage palm (swamp/hammock) and bald cypress/red maple/cabbage palm (swamp/low bottomland hardwood/hammock) communities are present and are categorized as Riverine Mixed (Rmix). Pond apples are found in the riverine swamps but are generally only associated with the riverbanks.

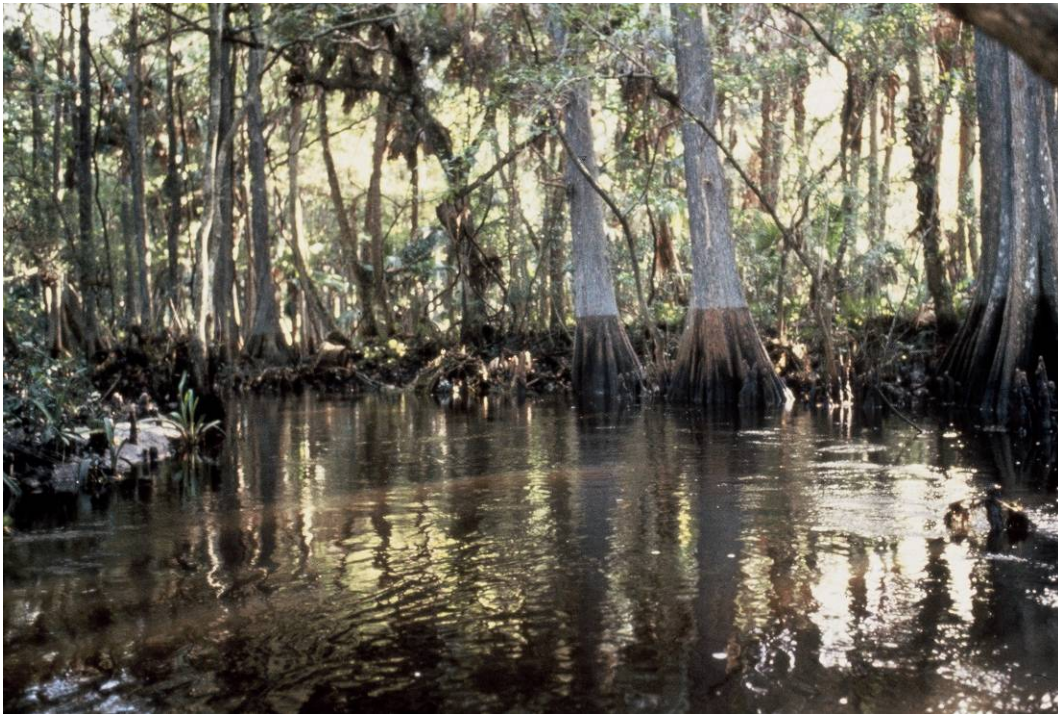
**Figure 3-9.** Example Forest Type Rsw1 (Bald Cypress Swamp).

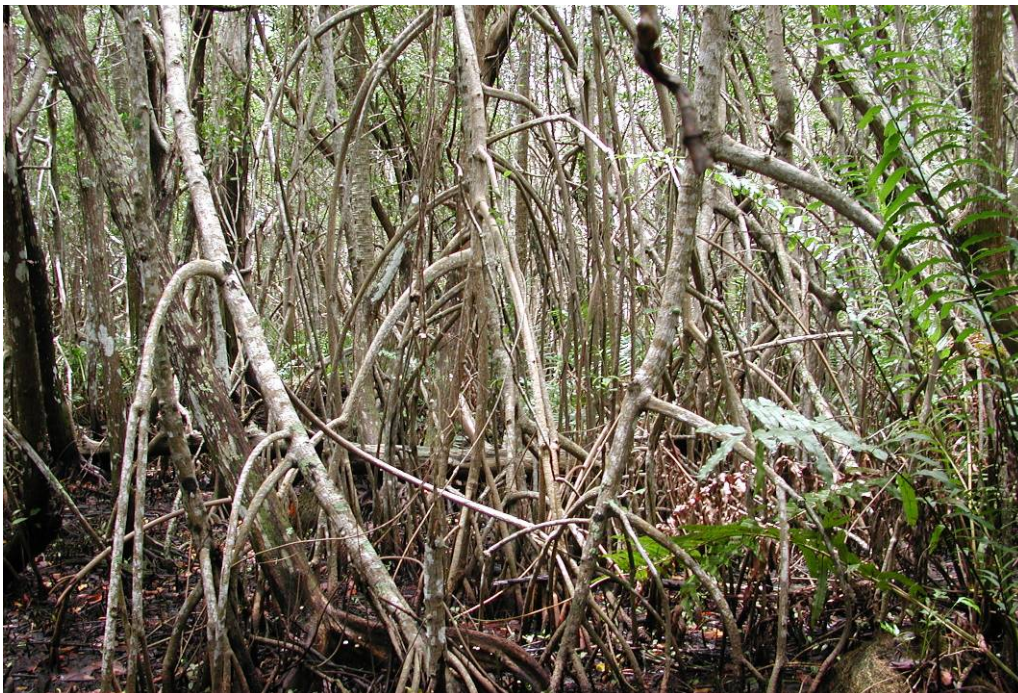
**Figure 3-10.** Example Forest Type LTsw1 (Red Mangrove Swamp).

Lower tidal forest types are primarily mangrove forest (i.e. swamps) with some areas of hammock which represent areas with very little change in topography within the floodplains. Soils are generally mucky with some areas of sand. LTsw1 is representative of a swamp dominated by red mangrove (**Figure 3-10**). The LTsw2 is representative of a white mangrove swamp with infrequent pond apple and red mangrove (**Figure 3-11**). Other plots contain mixtures of white mangrove, pond apple, and cabbage palm. If cabbage palm is at least 50% and white mangrove and pond apple are greater than 30% then the forest type is identified as lower tidal mixed (LTmixed). If cabbage palm and cocoplum (*Chrysobalanus icaco*) are greater than 75% then the forest type is identified as hammock. Cabbage palm is found intermixed and in clumps with swamp species; however those palms that were found at these low elevations and exposed to salt water did not appear to be as healthy as those found at obviously higher elevations. Other palms were found growing on small mounds of hummocks. Today, cabbage palms are quite common along the shoreline of the tidal Northwest Fork of the Loxahatchee River. The river channel has widened between 1940 and 1995 along the shoreline between the JDSP boundary and Trapper Nelson's Interpretative Site (SFWMD, 2002). This widening suggests that erosion has occurred within these cabbage palm communities leaving them exposed to greater tidal fluctuations and saltwater exposure.

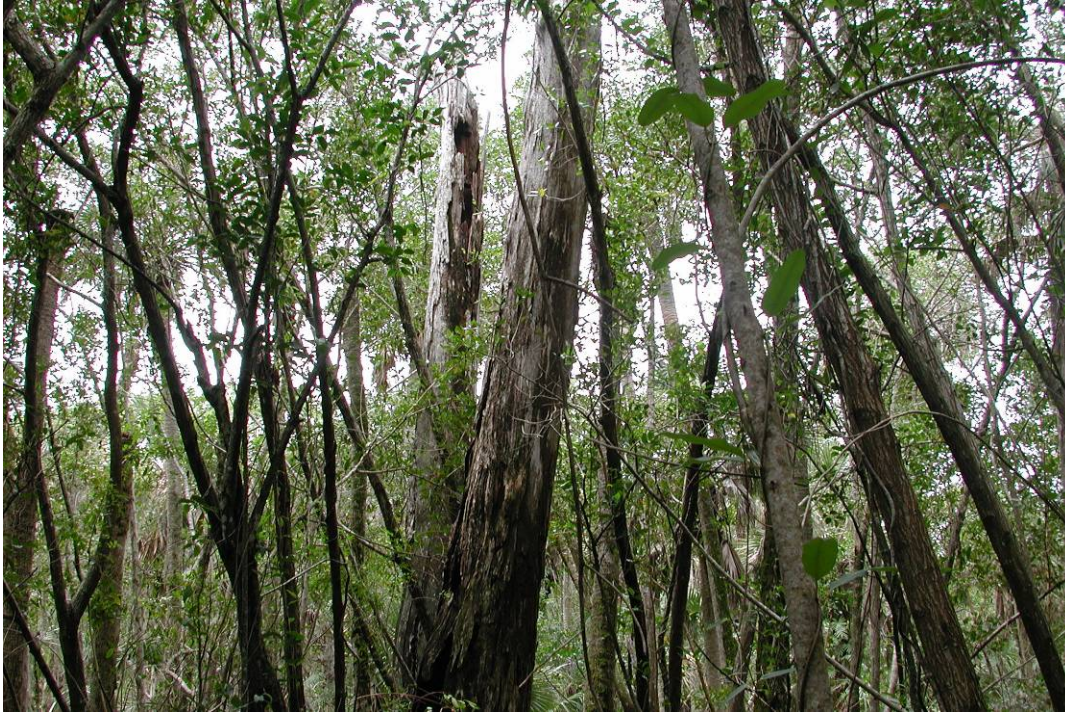
**Figure 3-11.** Example Forest Type LTsw2 (White Mangrove Swamp with Dead Bald Cypress).

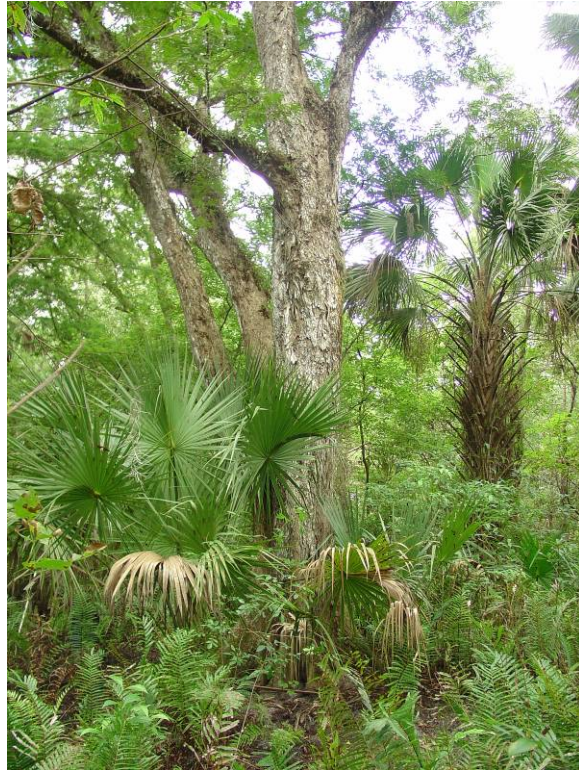
**Figure 3-12.** Water Hickory in Bottomland Hardwood Plot on Transect #4.

Transect #4 is located at RM 11.18 on the west side of the river approximately 1 mile upstream of Trapper Nelson's Interpretive Site. This transect is just downstream from an old logging road that crossed the floodplains and river. There are several elevation changes between the upland edge of the floodplain and the riverbed. The benchmark for this site is a very large dead pine tree, which is on the slope at about 5.62 feet NGVD. From the hammock the transect drops down into several Rsw1 plots intermixed with plots of Rlbh2 and Rlbh3 (**Appendix A, Table 1D; Appendix B**). Bottom elevations of the swamp plots are approximately 2.17 feet NGVD while the bottom of the river channel is -2.45 feet NGVD (**Appendix C**). Most of the plots closer to the river are bottomland hardwood with some of the largest water hickory observed in the watershed (**Figure 3-12**). Some of these large hickory trees exhibit the allelopathic nature of this species as little groundcover or shrubs are present beneath their canopy. Elevations of the Rlbh2 and Rlbh3 plots are approximately 2.51 feet to 3.91 feet NGVD. The average dbh of water hickory on the transect is 36.1 cm and with the largest at 88.6 cm. Bald cypress trees vary considerably in size and age across Transect #4. The average cypress dbh is 30.0 cm; but the dbh ranges from 5.7 cm to 83.6 cm indicating that several generations of trees are present. Pop ash and red maple averaged 12.2 cm and 11.0 cm dbh, respectively. Shrubs and groundcover are primarily leather fern, maiden's fern, downy shield fern, Virginia willow, swamp fern, royal fern, lizard's tail, swamp lily, and pond apple. Witch grass is present on the bottomland hardwood plots.

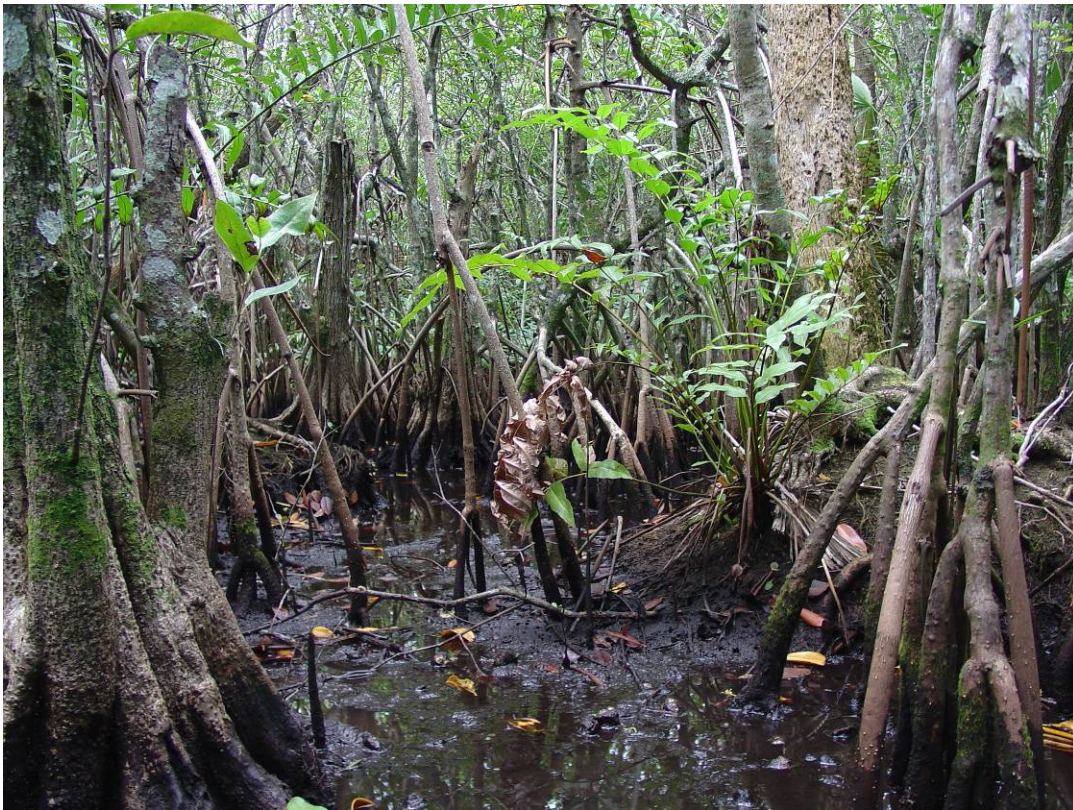
**Figure 3-13.** Cabbage Palm Utilizing a Hummock Among Red Mangroves and Pond Apples (UTsw1) on Transect #6.

Transect #6 is located at RM 8.4 on a peninsula just upstream of Kitching Creek and adjacent to National Audubon's Ornamental Garden (Kitching Creek Sanctuary). This peninsula has been selectively logged in the past and contains the remnants of many dead cypress trees. Today, there are still live cypress trees growing among the pond apples and mangroves and a band of cypress trees still exist adjacent to the uplands. Elevations range from 6.82 feet NGVD in the uplands to an average elevation of 1.59 feet NGVD over the remaining length of the transect (**Appendix C**). Of the 16 plots on Transect #6, there are 2 Upland, 1 Rsw1, 6 UTsw1, 6 UTsw3, and 1 UTmix plots (**Appendix A, Table 1E**). The most prevalent species are red and white mangrove and pond apple with an average dbh of 8.3 cm (**Appendix B**). Red maple (dbh 17.5 cm) and pop ash (average dbh 5.7 cm) are present in much smaller numbers. The average dbh of the living bald cypress trees is 29.8 cm. Approximately 85 meters from the uplands on Transect #6, there is a large, healthy bald cypress tree totally surrounded by red mangroves. Red mangrove and pond apple are more prevalent in the plots beyond 110 meters from the uplands, which demonstrates the significance of floodplain topography in species distribution. Shrubs and groundcover consist primarily of very young red and white mangrove, leather fern, pond apple, buttonbush, maiden fern, swamp fern, and rubber vine (*Rhabdadenia biflora*).

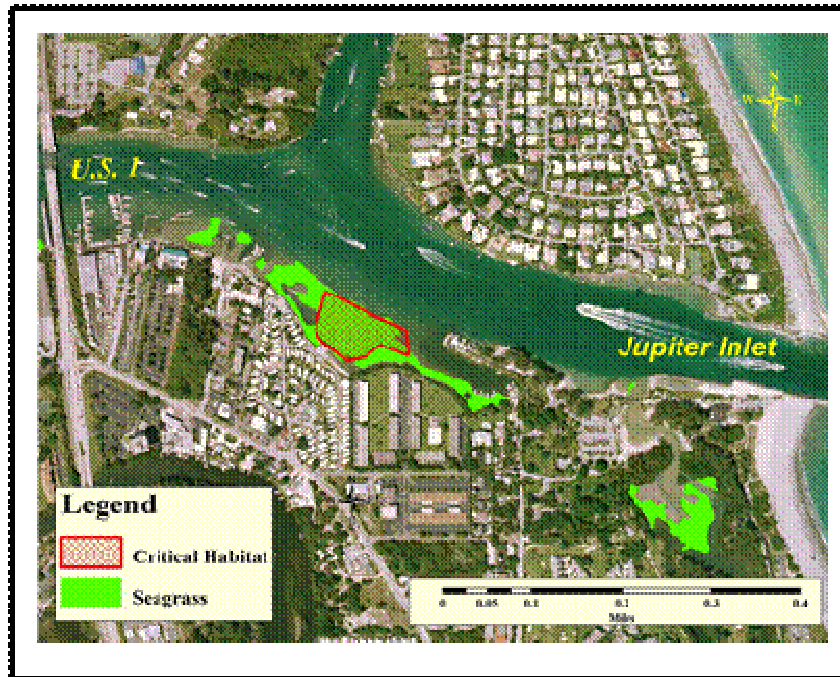
**Figure 3-15.** Critical Habitat for Johnson's Seagrass Within the Loxahatchee Estuary.

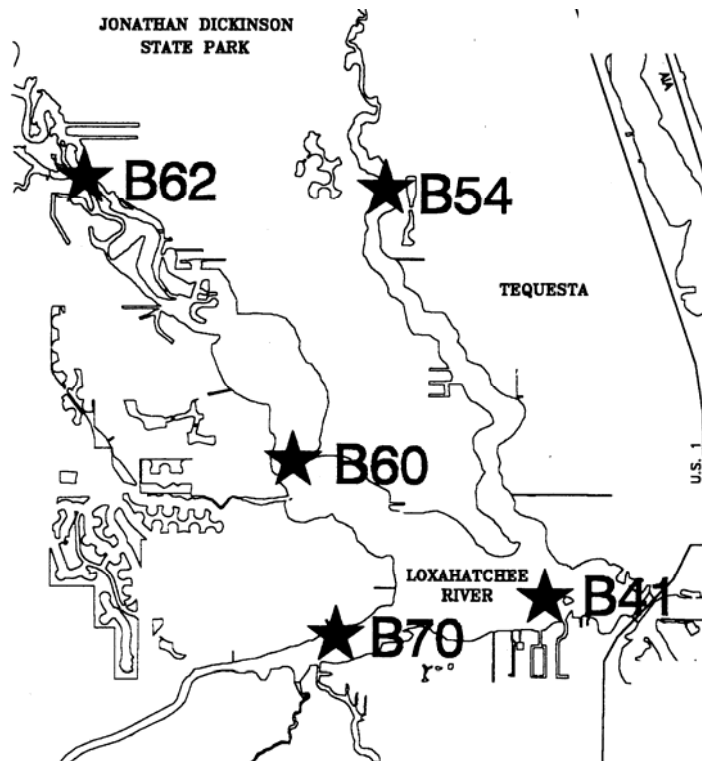
**Figure 3-16.** Location of Loxahatchee Estuary Macroinvertebrate Sampling Stations Used by Dent et al., 1998.

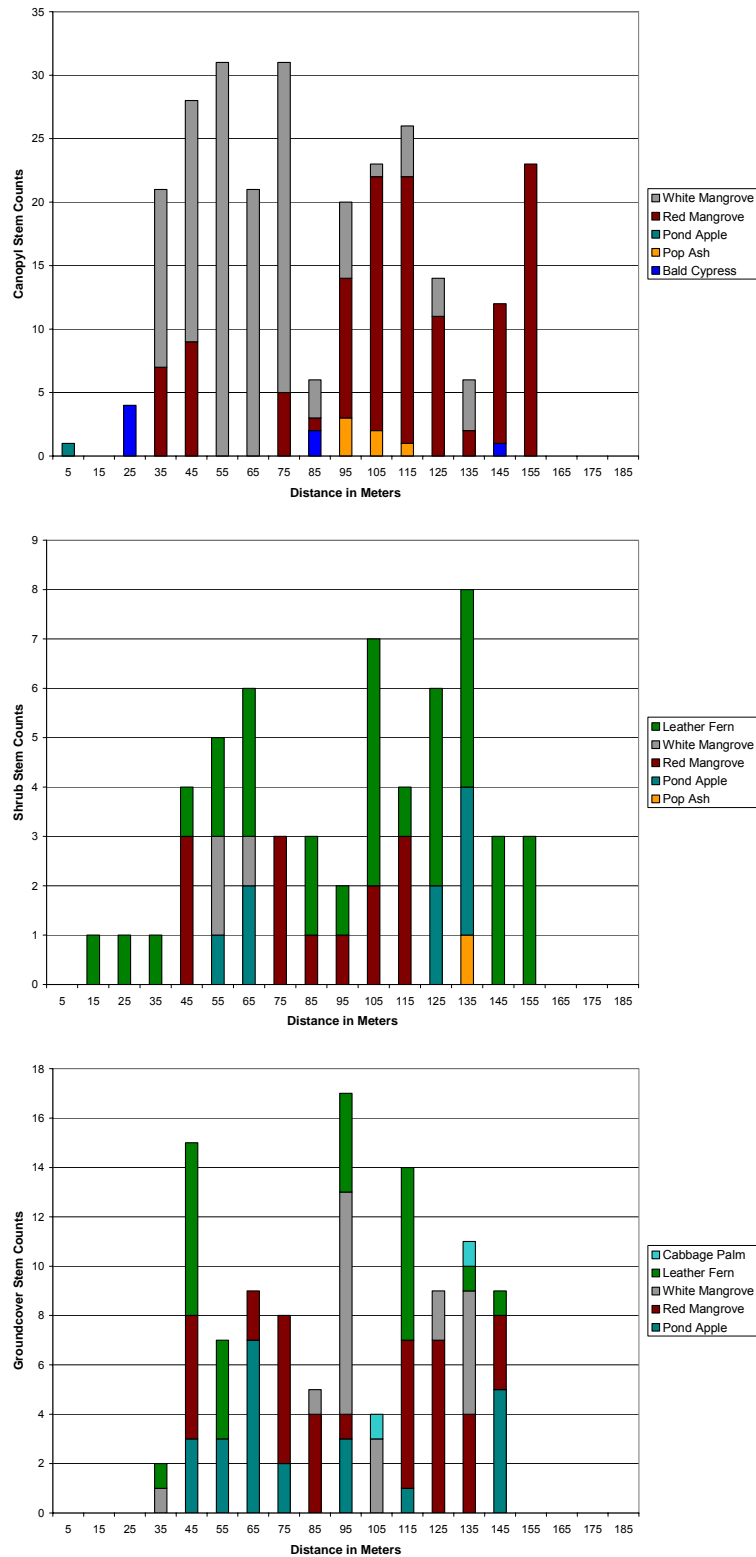
**Figure 4-1.** Select Canopy, Shrub, and Groundcover Species by Distance (in m) from the Uplands for Transect #6: Upper Tidal Reach.

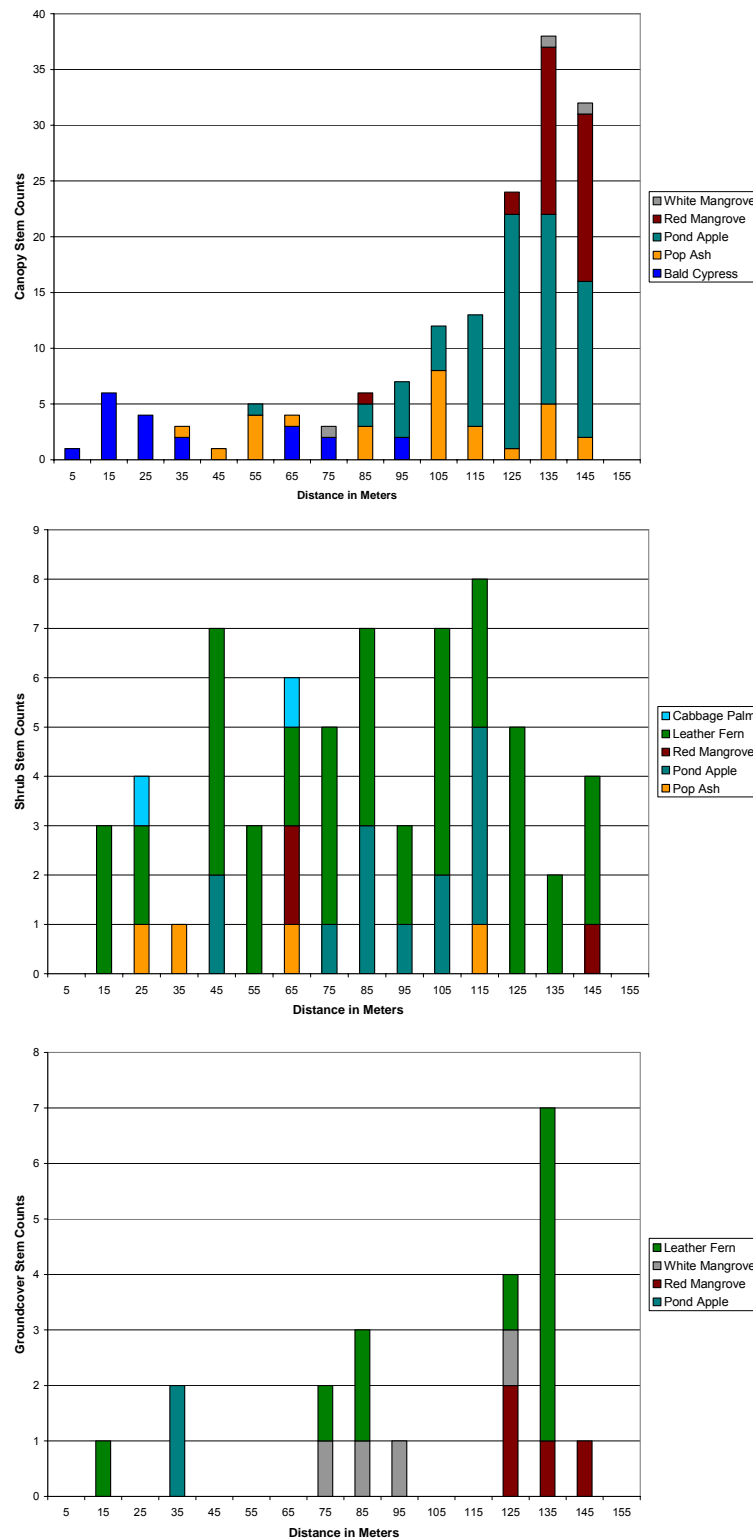
**Figure 4-2.** Select Canopy, Shrub, and Groundcover Species by Distance (in m) from the Uplands for Transect #7: Upper Tidal Reach.

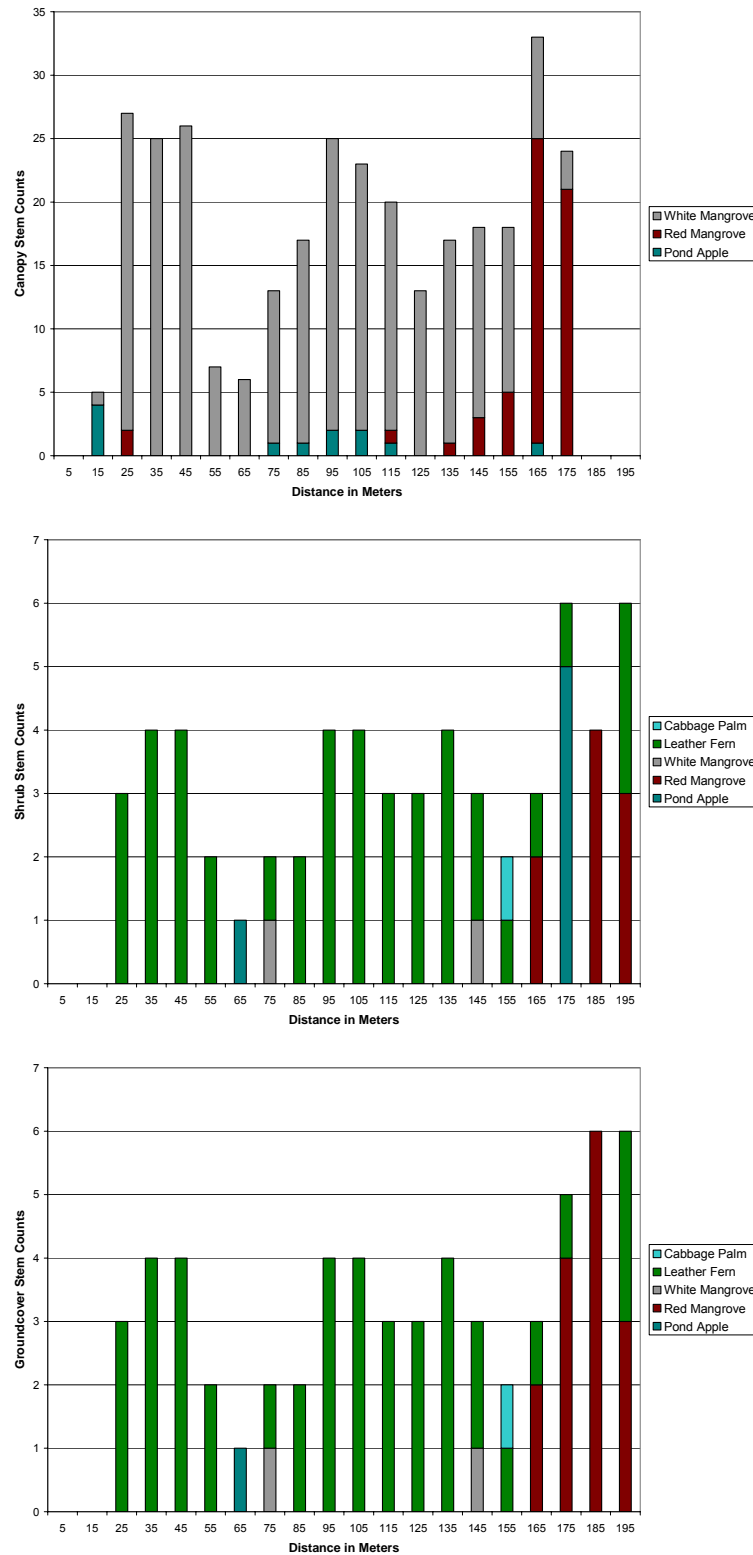
**Figure 4-3.** Select Canopy, Shrub, and Groundcover Species by Distance (in m) from the Uplands for Transect #9: Lower Tidal Reach.

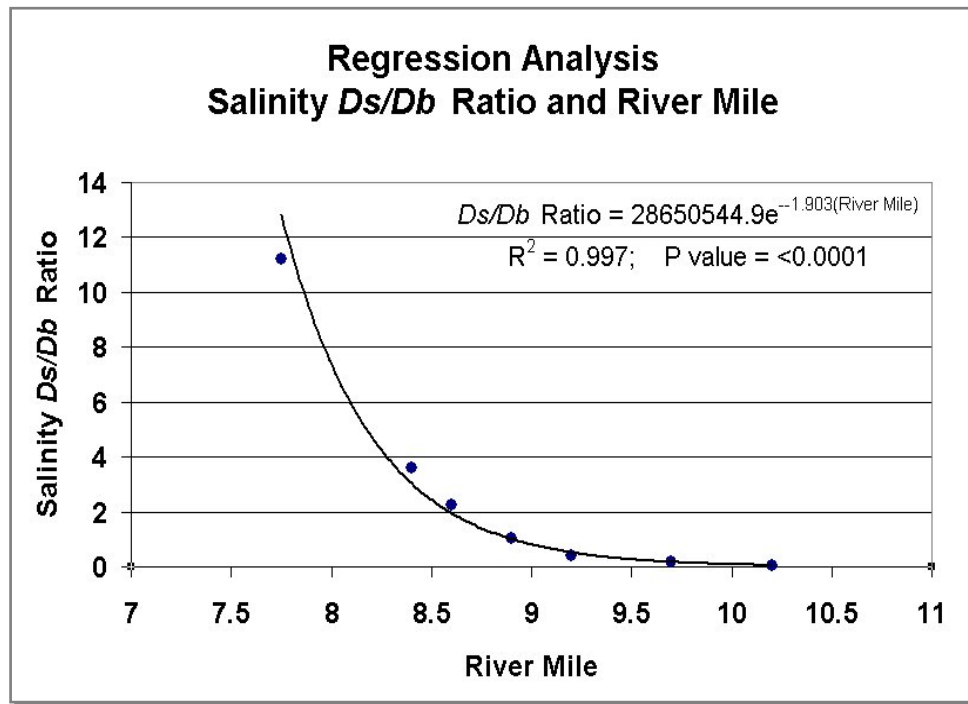
**Figure 4-4.** Correlation Between Salinity Event Ratio *Ds/Db* (> 1 ppt) and River Mile.

The characteristic salinity regimen at a site in the Northwest Fork is defined by a ratio of the duration of all salinity events ( $D_s$ ) over the duration of between these salinity events ( $D_b$ ) over a long period of time such as over 30 years. The  $D_s/D_b$  ratio integrates salinity exposure duration, magnitude and recovery time between salinity events into a single numerical factor. In **Chapter 6**, we present the long-term salinity data that are predicted by a salinity management model. SFWMD staff concluded that the salinity regimen ratio  $D_s/D_b$  (using 1 ppt threshold) showed a highly significant ( $p < 0.0001$ ) negative correlation ( $r^2 = 0.997$ ) with distance from the Jupiter Inlet (**Figure 4-4**). As the site moves upstream, the  $D_s/D_b$  ratio approaches zero since fewer salinity events occur. In contrast, the  $D_s/D_b$  ratio exceeds one and rapidly increases downstream as the magnitude and duration of each salinity event increases, and the time between salinity events decreases. Use of the  $D_s/D_b$  ratio affords a closer “fit” to salinity conditions than would have been provided by the use of standard descriptive statistics. SFWMD staff further found that the abundance and diversity of vegetation along the river corridor of the Northwest Fork is closely correlated to the salinity ratio, which provides a reasonable estimate of the status of the vegetation community at a site (Zahina, 2004). In **Chapter 7**, we demonstrate how increasing fresh water inflows into the Northwest Fork in the dry season would change this salinity characteristic regimen, and ultimately change the tidal floodplain vegetation.

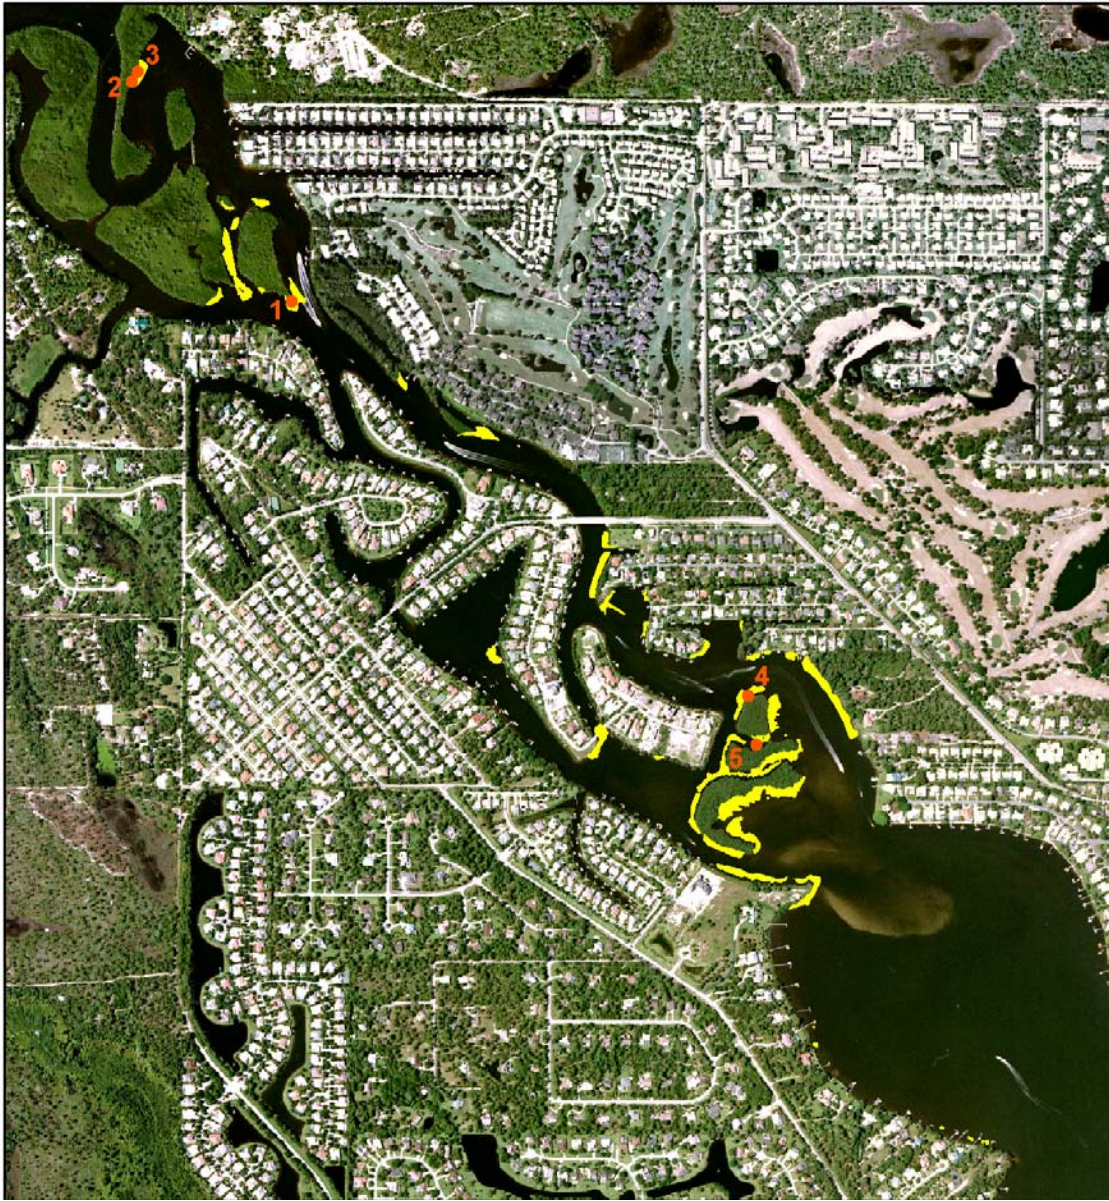
**Figure 4-5.** Oyster Bed Distribution (yellow) in the Northwest Fork of Loxahatchee River Conducted in 2003. Monitoring Stations are Marked as Red Dots.

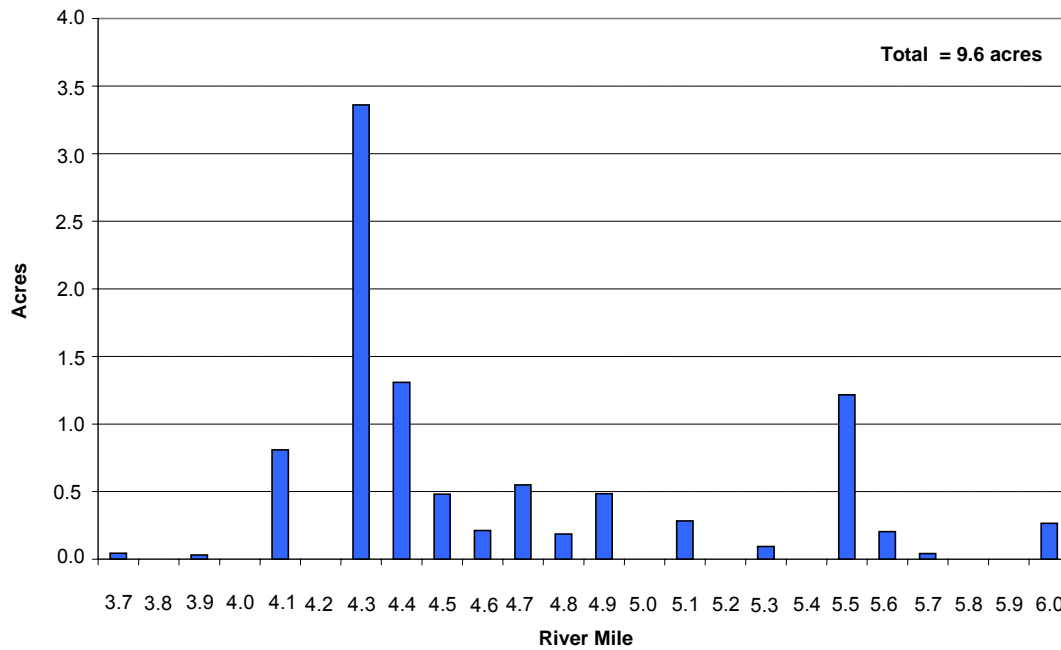
**Figure 4-6.** Oyster Acreage in the Northwest Fork of the Loxahatchee River Estuary.

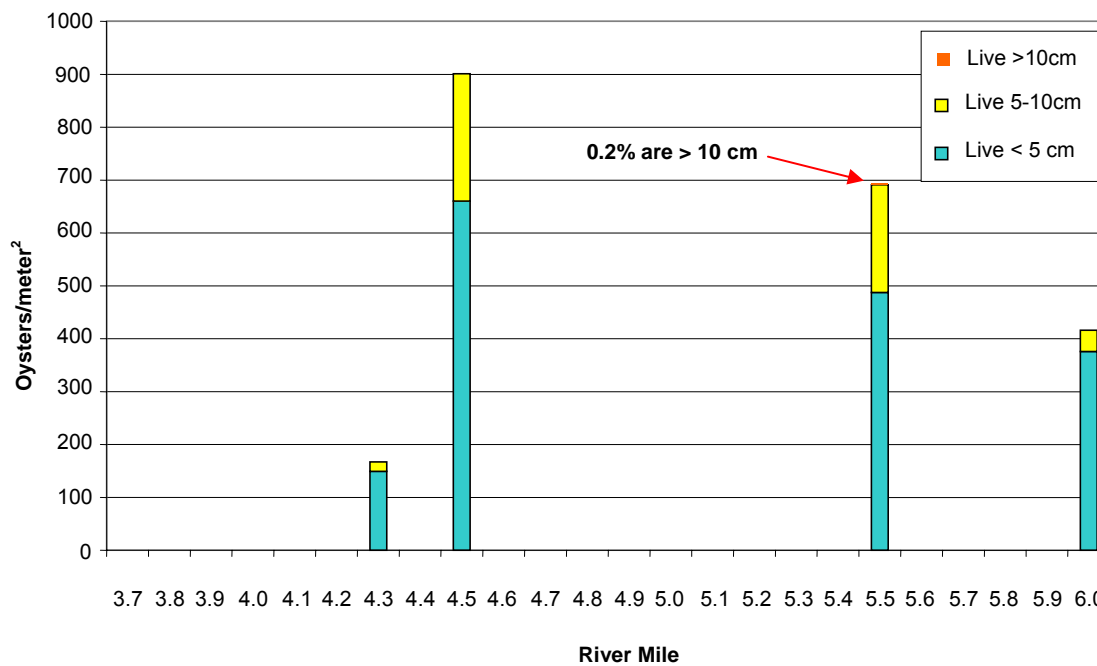
**Figure 4-7.** Oyster Distribution in the Northwest Fork of the Loxahatchee River Estuary.
